NAVAL FACILITIES ENGINEERING SERVICE CENTER
Port Hueneme, California 93043-4328

Technical Report TR-2040-OCN

FDS-D WET-END SURVIVABILITY POST TEST ANALYSIS

March 1995

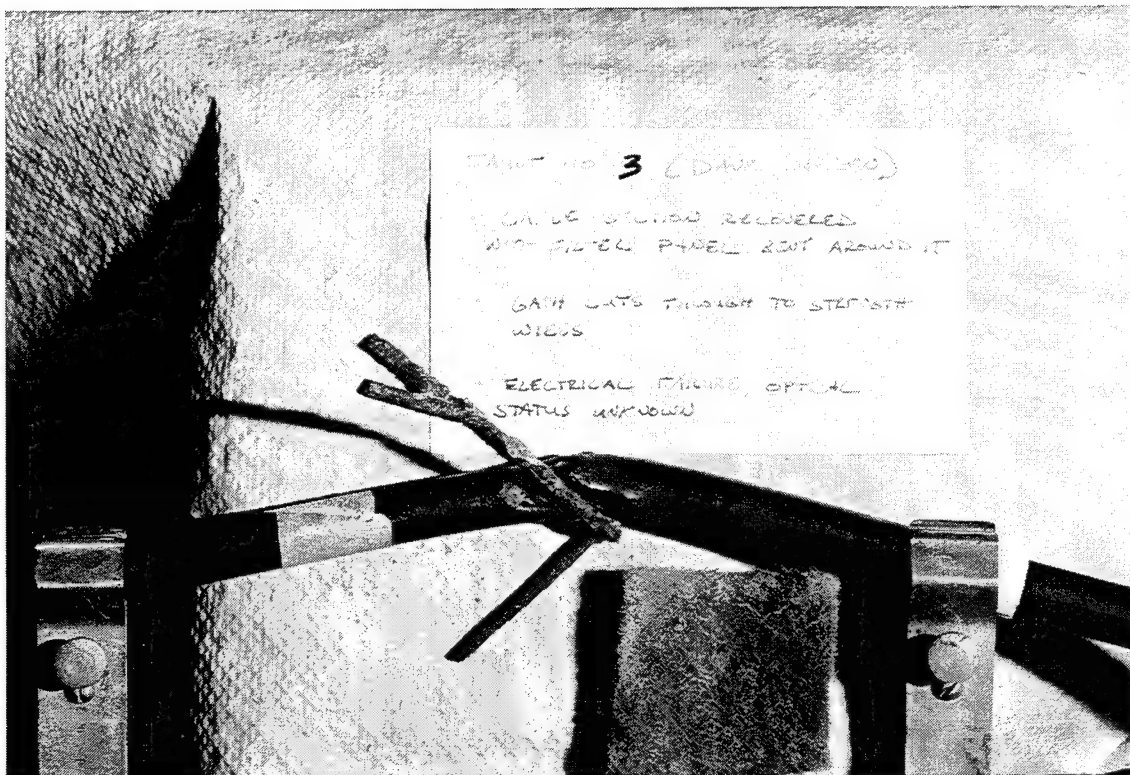
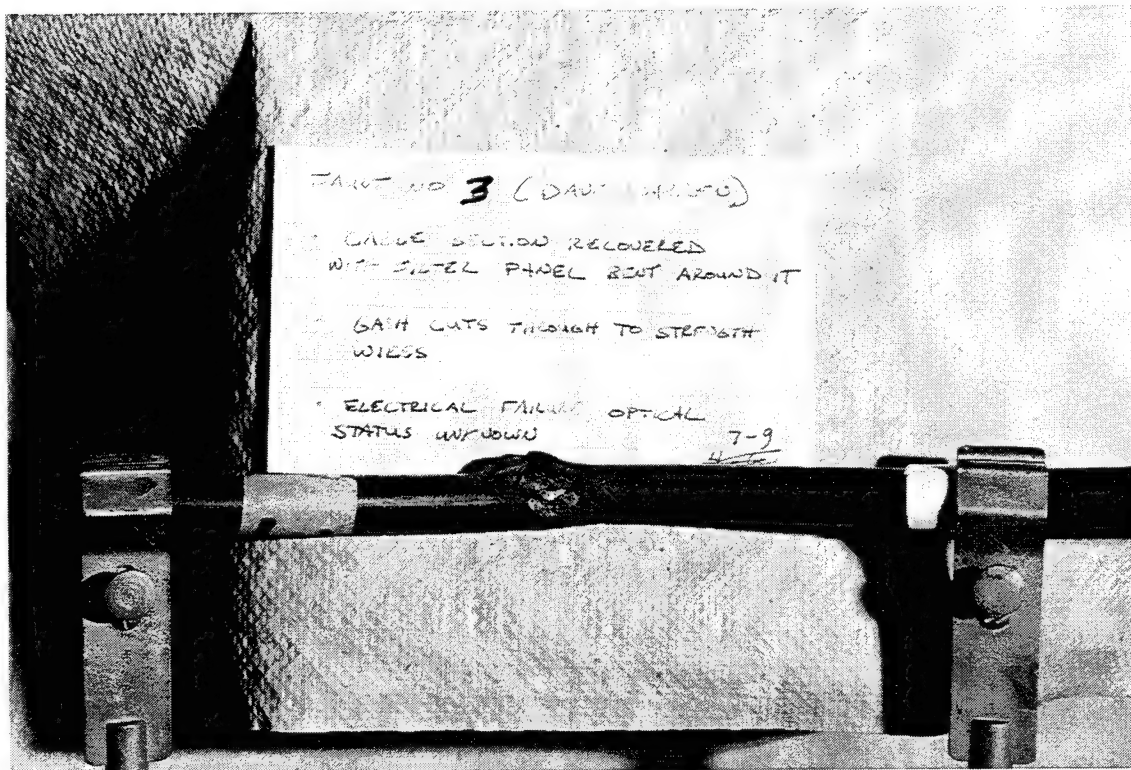
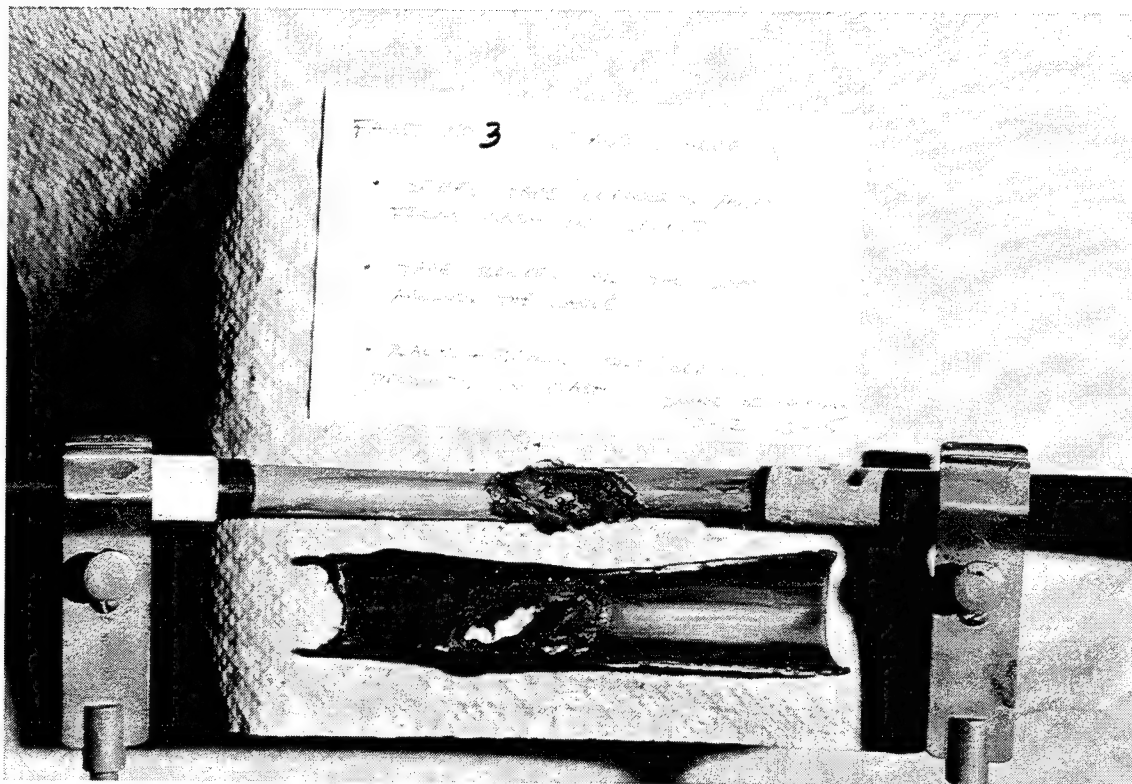
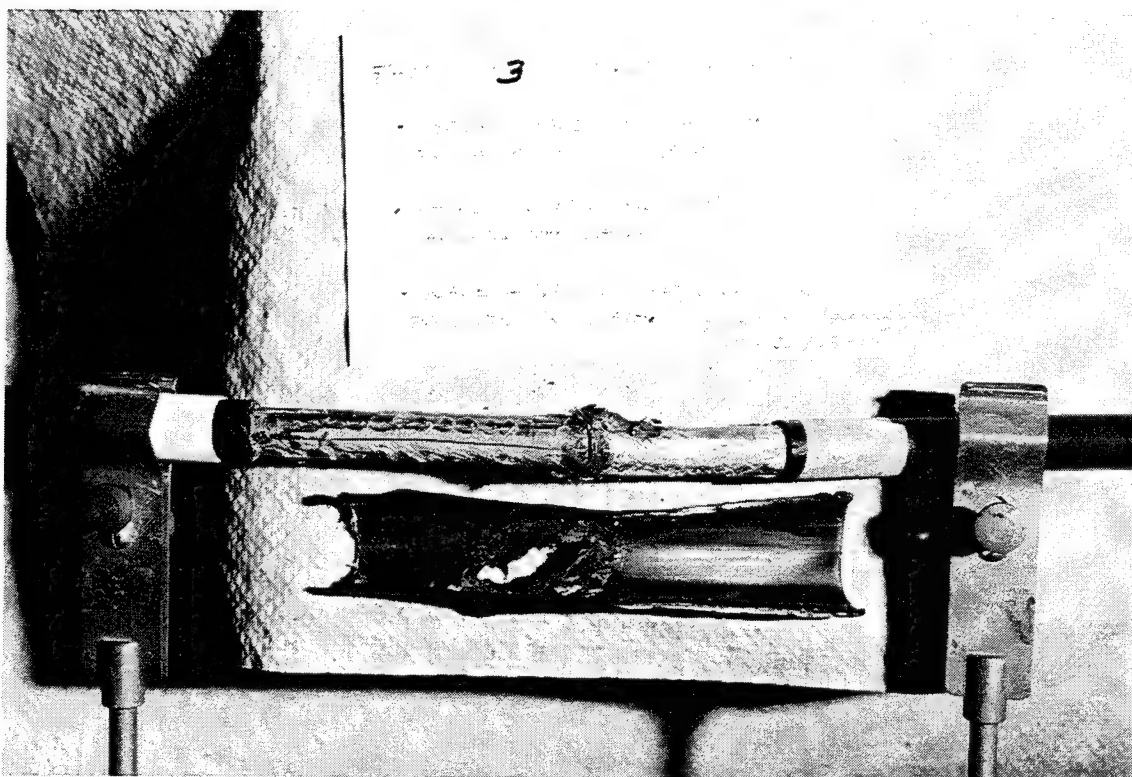
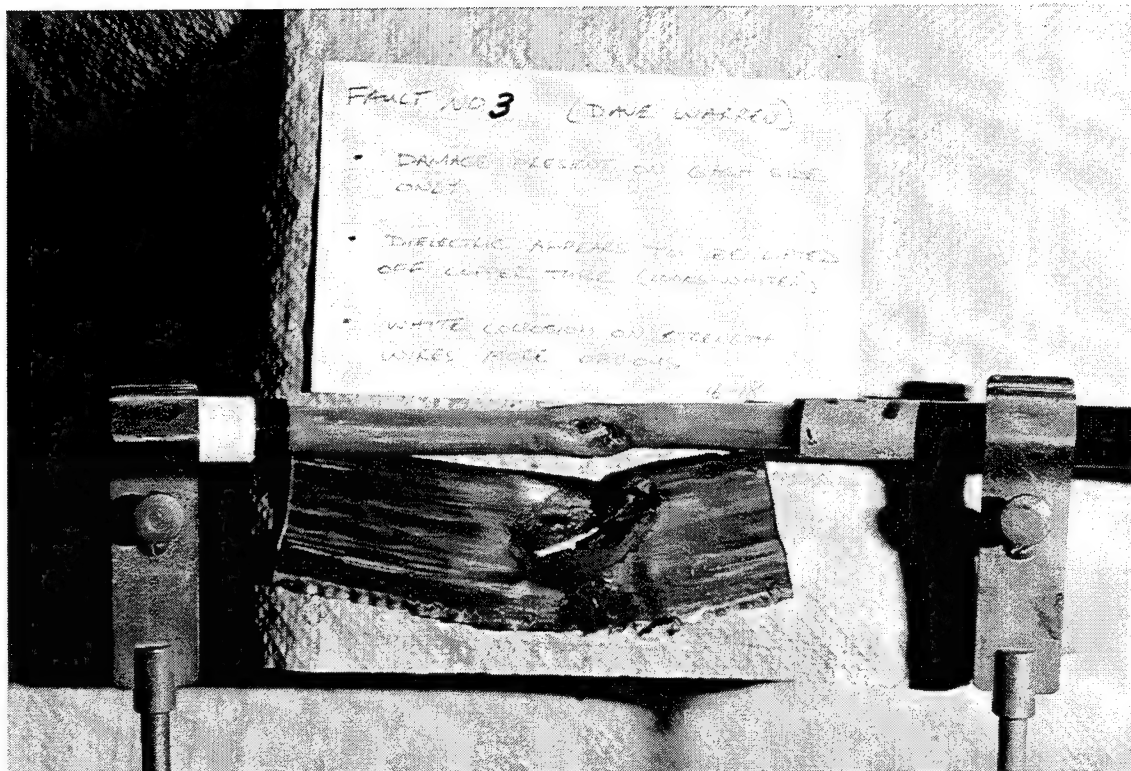
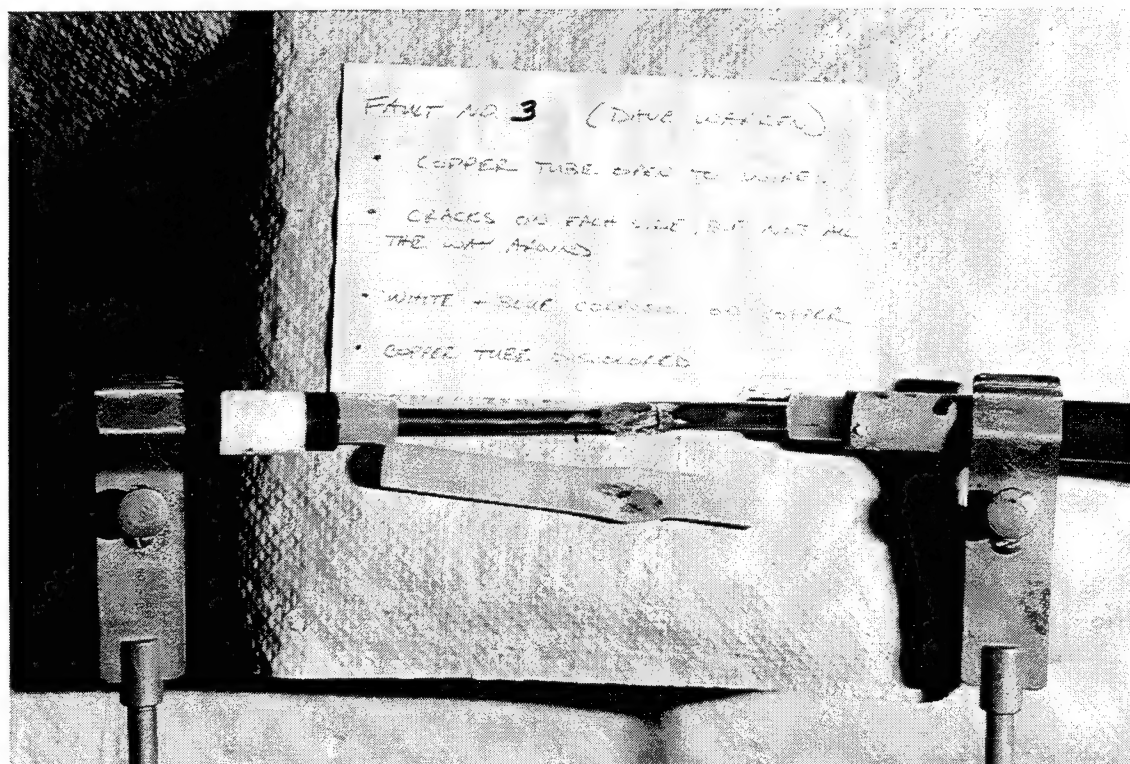
5.5 Fault Number 3 - FDS-D CABLE AUTOPSY WORKSHEET

Condition of Optical Fiber Sheath: The sheath has cold flowed into spaces between inner layer of strength wires. Sheath is discolored (yellow/mustard) corrosion from wires stuck on the sheath.

Condition of Fiber: Unknown. Attempted to check with a bare fiber adapter - unsuccessfully, but can't say that the fiber is bad. Fiber may be broken at the point where the pigtail emerges from the end of the sample.

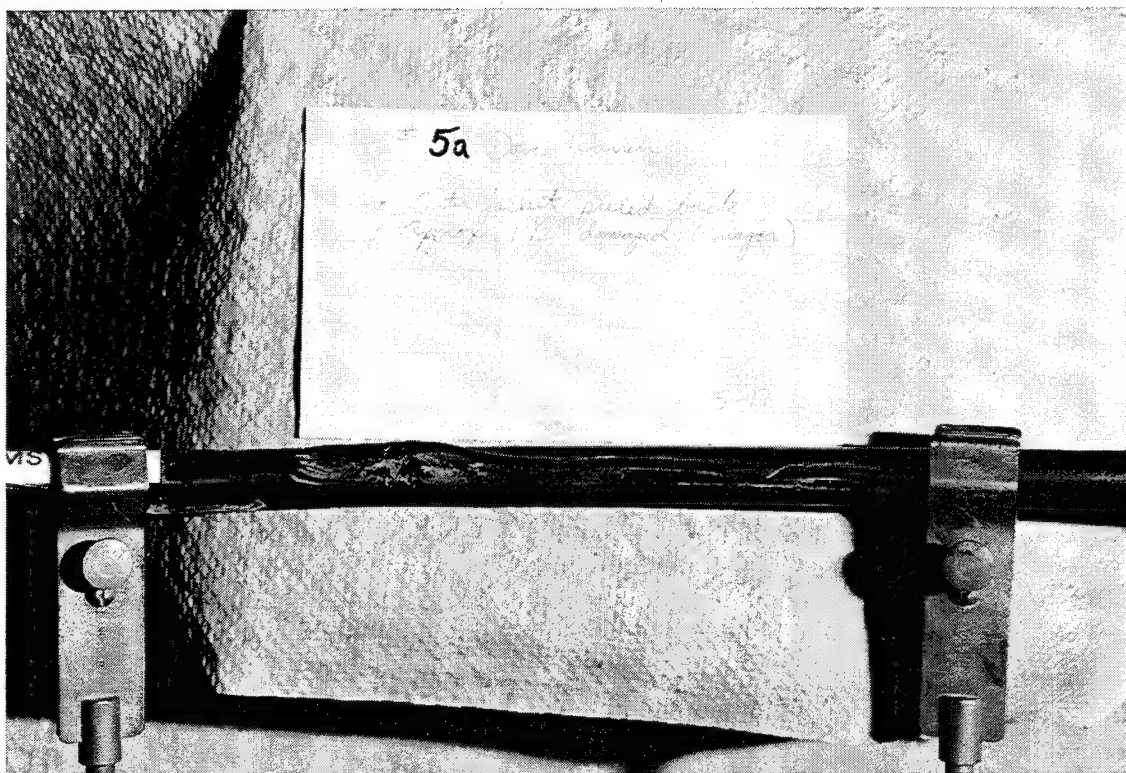
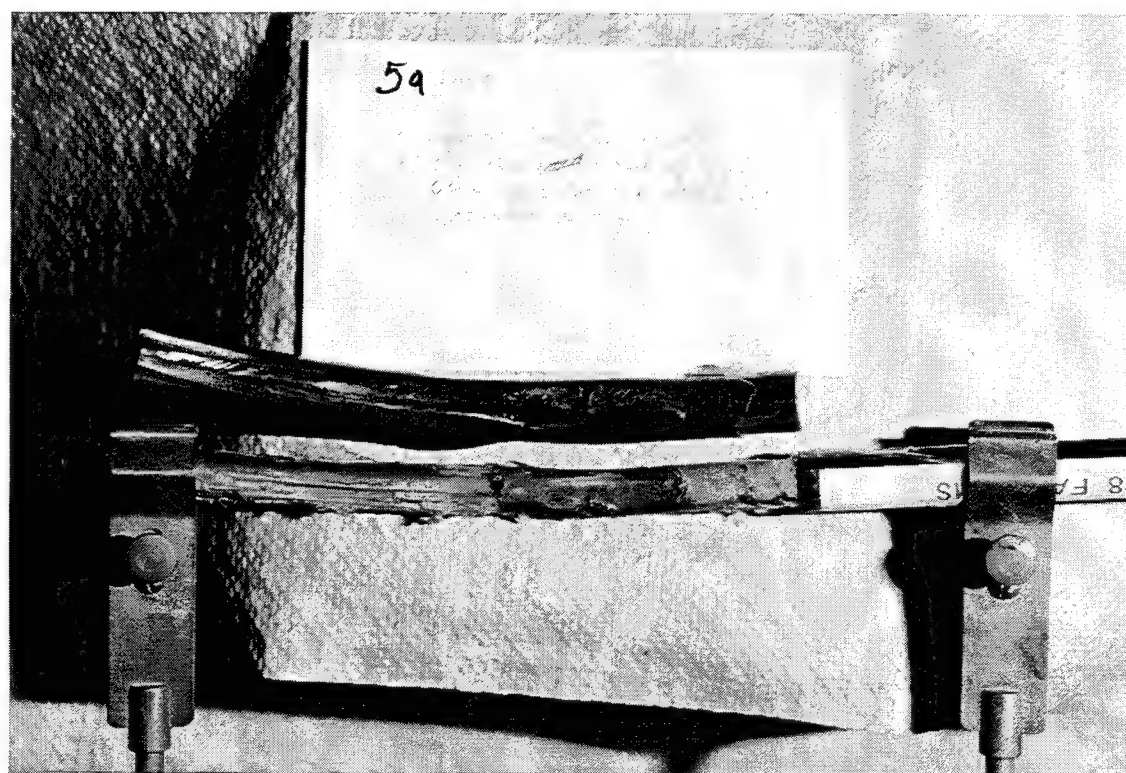
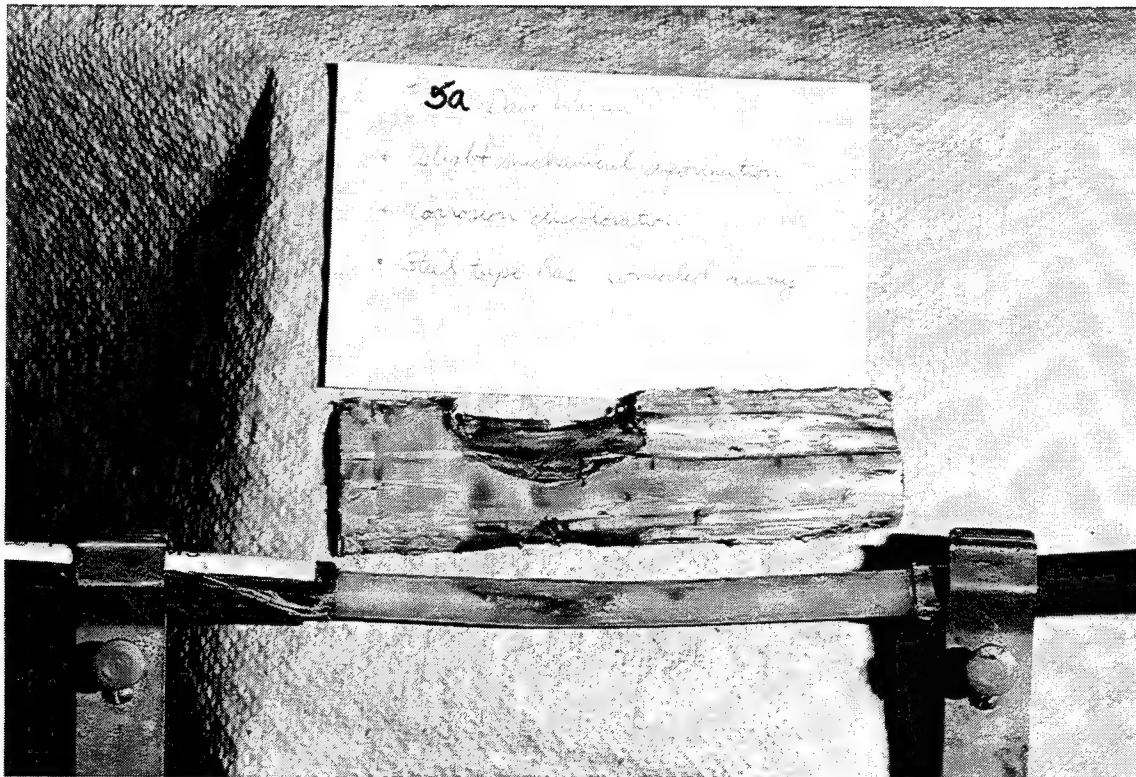
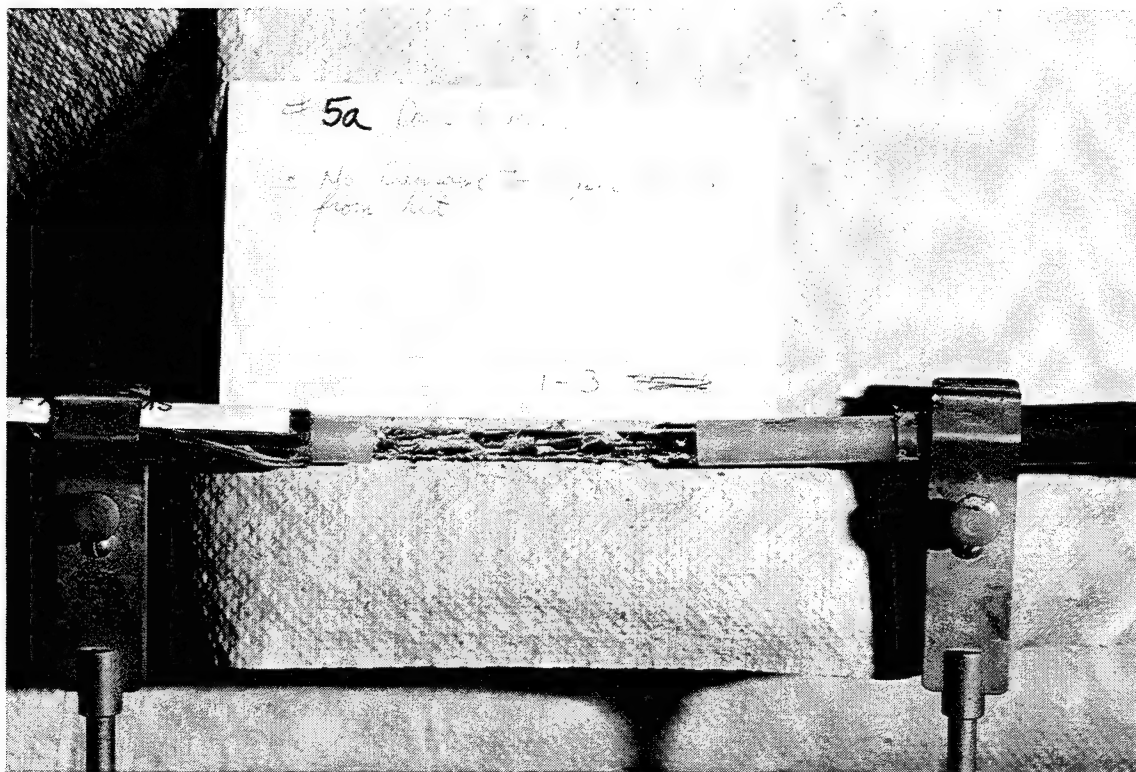
5.6 Fault Number 5a - FDS-D CABLE AUTOPSY WORKSHEET

Condition of Optical Fiber Sheath: Not inspected.

Condition of Fiber: Performed a power meter check with one splice and one pare fiber adapter. The fiber checked out good.

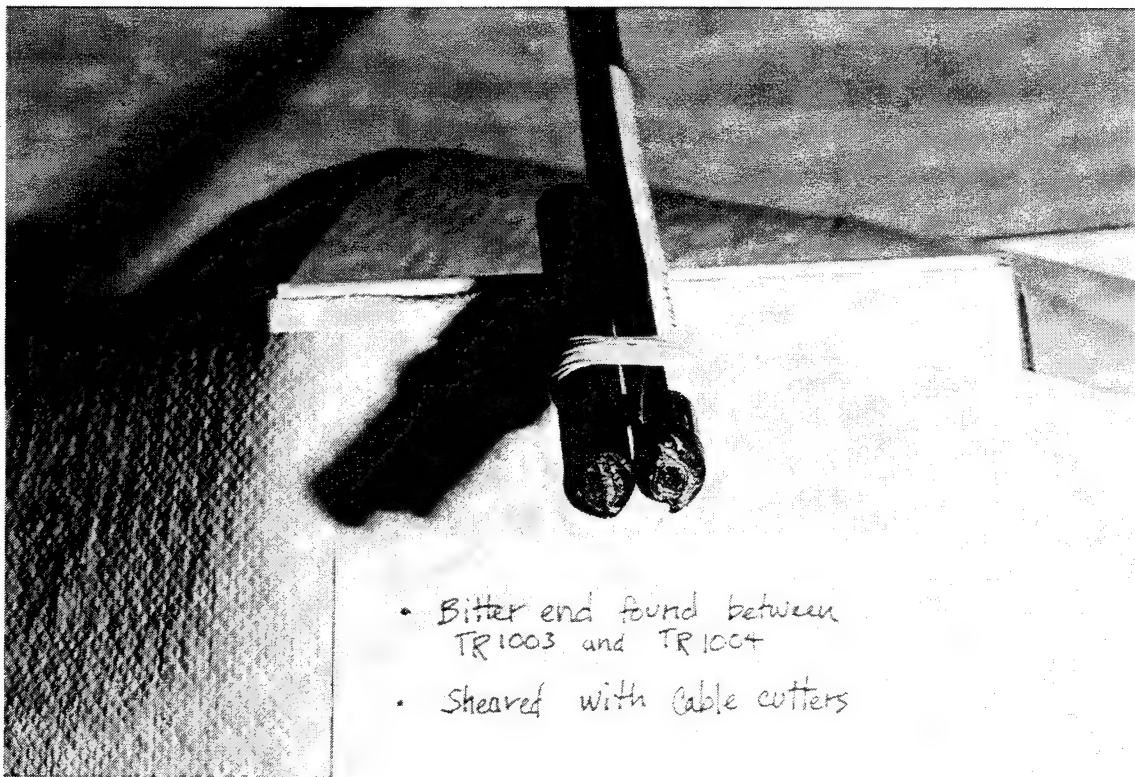
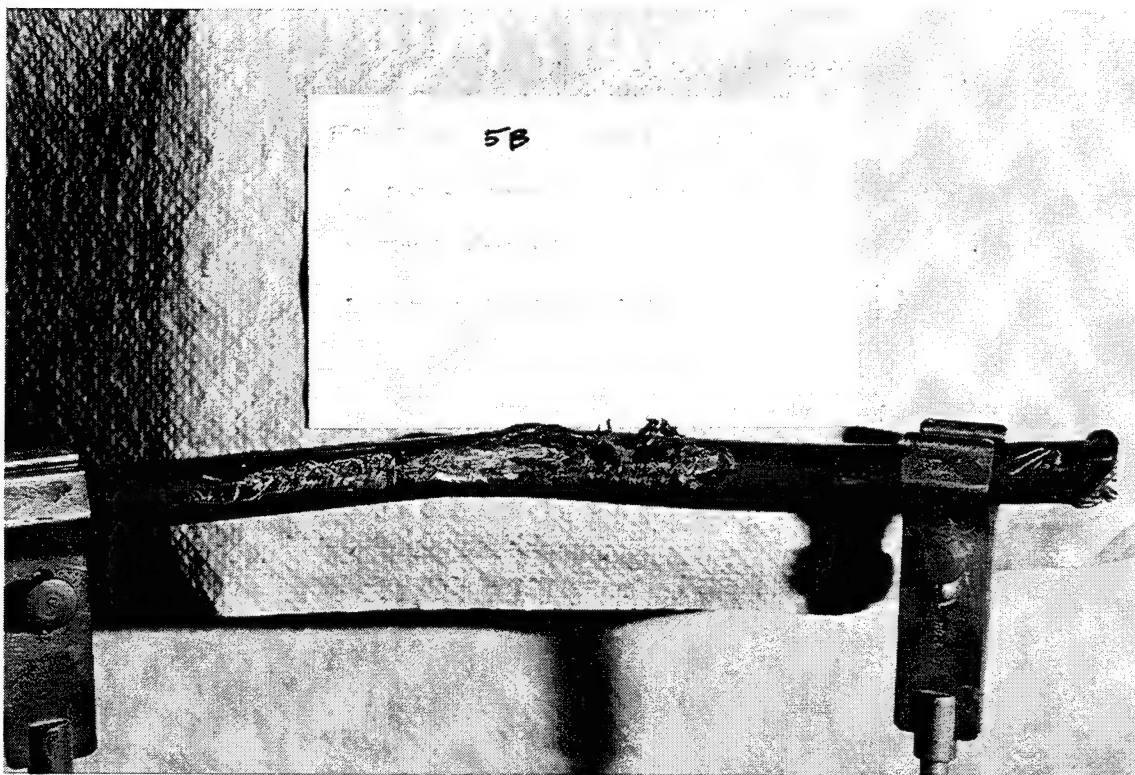
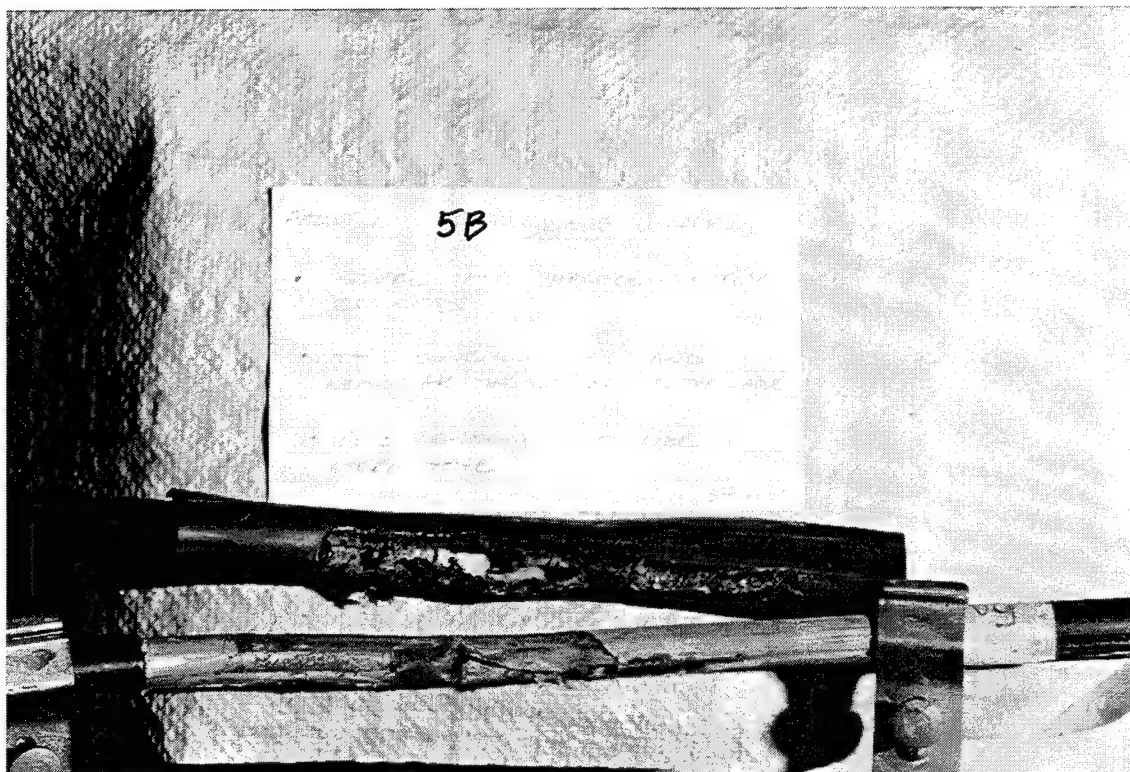
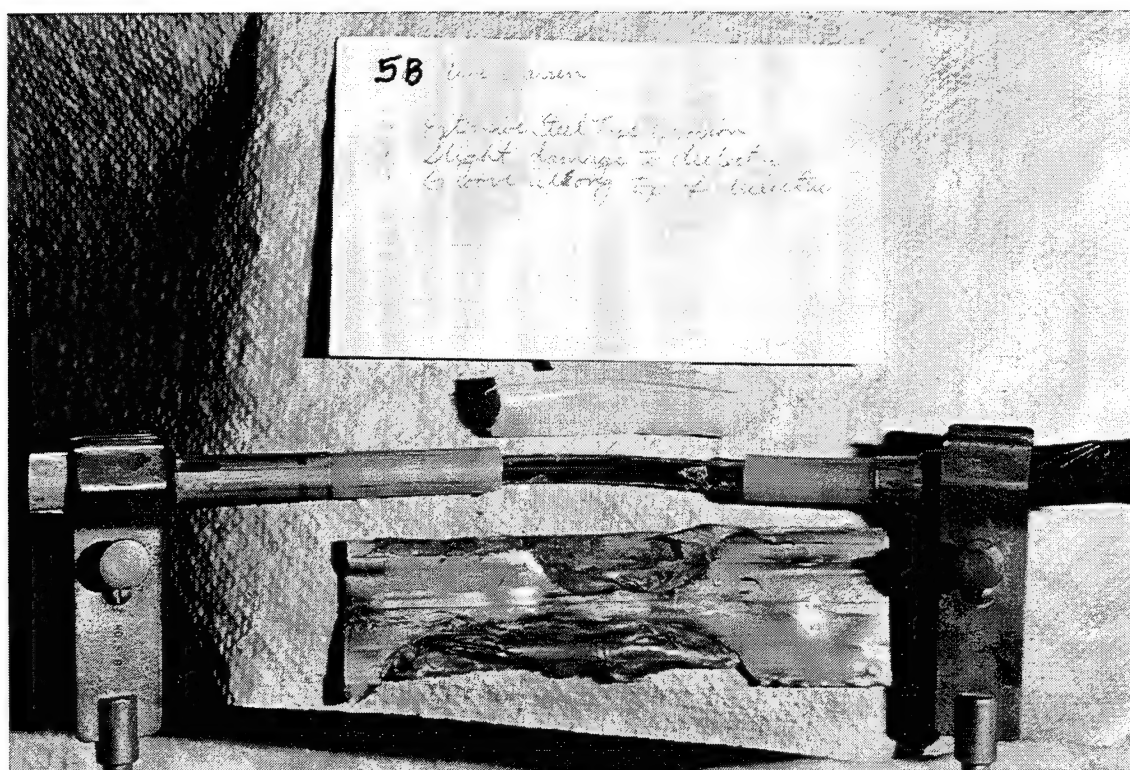
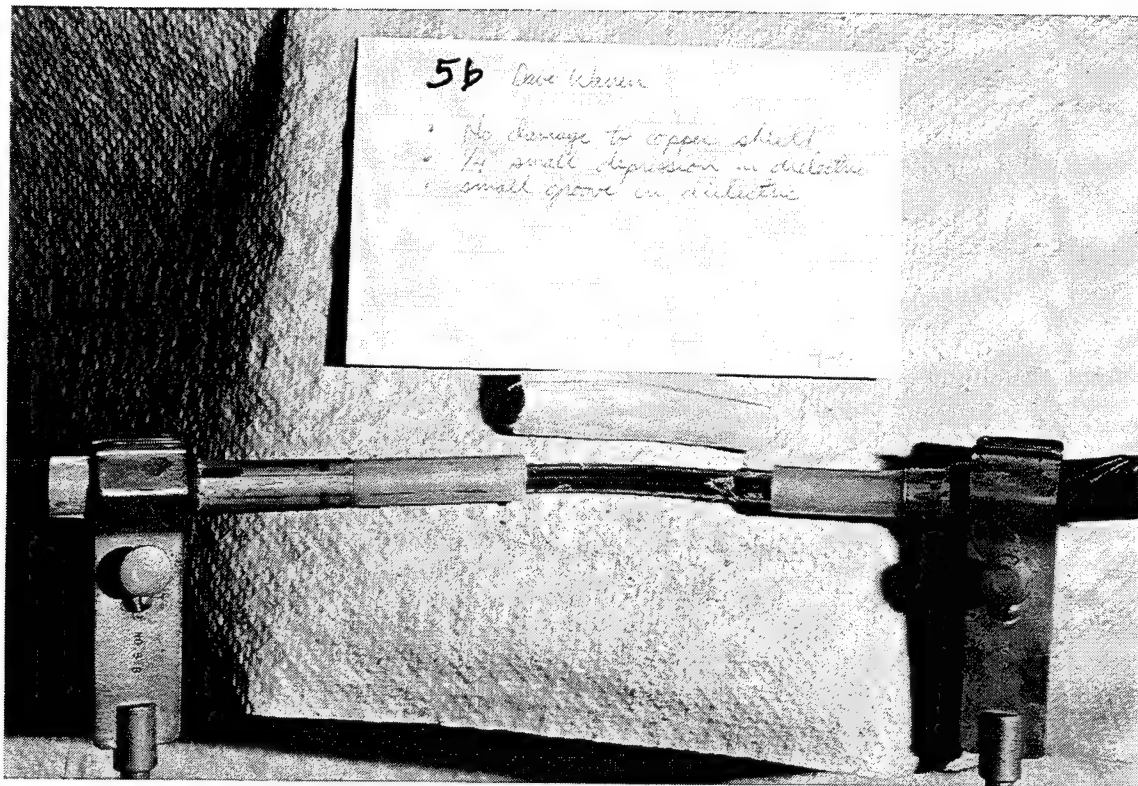
5.7 Fault Number 5b - FDS-D CABLE AUTOPSY WORKSHEET

Date Recovered: 8/ /94 Date Autopsied: 10/20/94
Autopsy Personnel: Carl Stevens, Steve Smuck
Date of Failure: Between 271200Z Jun 94 and 071400Z Aug 94
Location: 1.2 NM seaward of TR1004
Depth: 290 fathoms
Seafloor: Soft mud.

Condition of Optical Fiber Sheath: Not inspected.

Condition of Fiber: Not inspected.

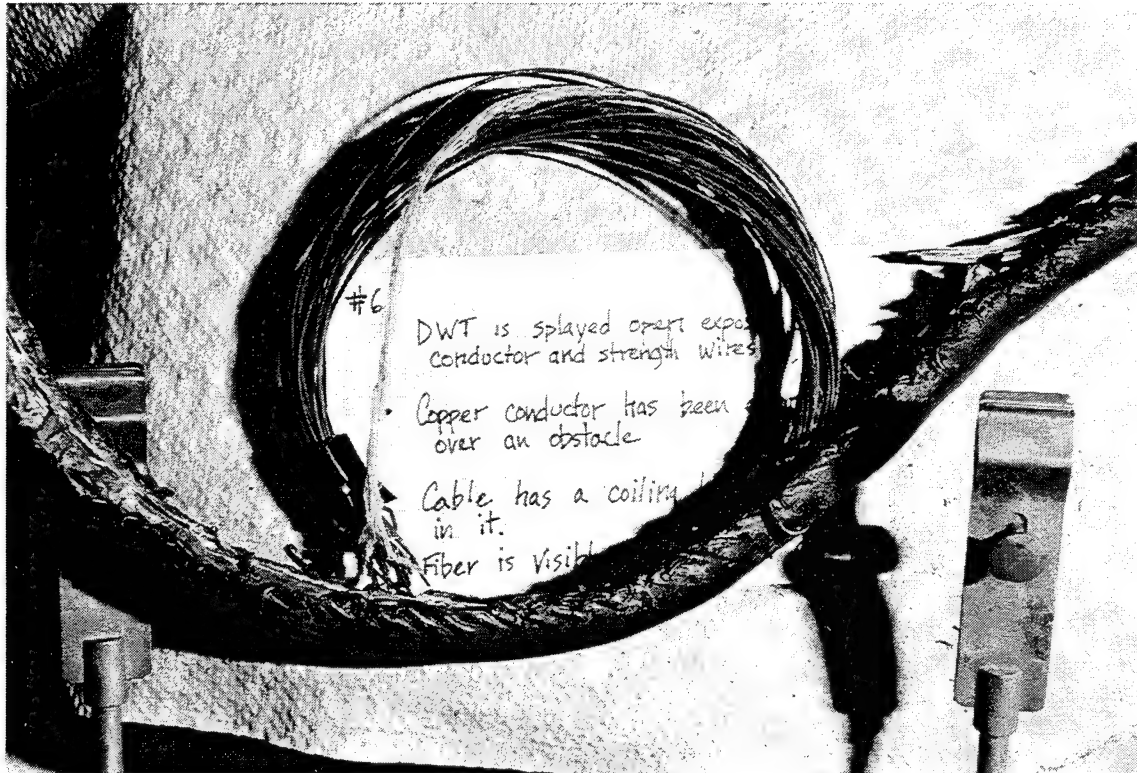
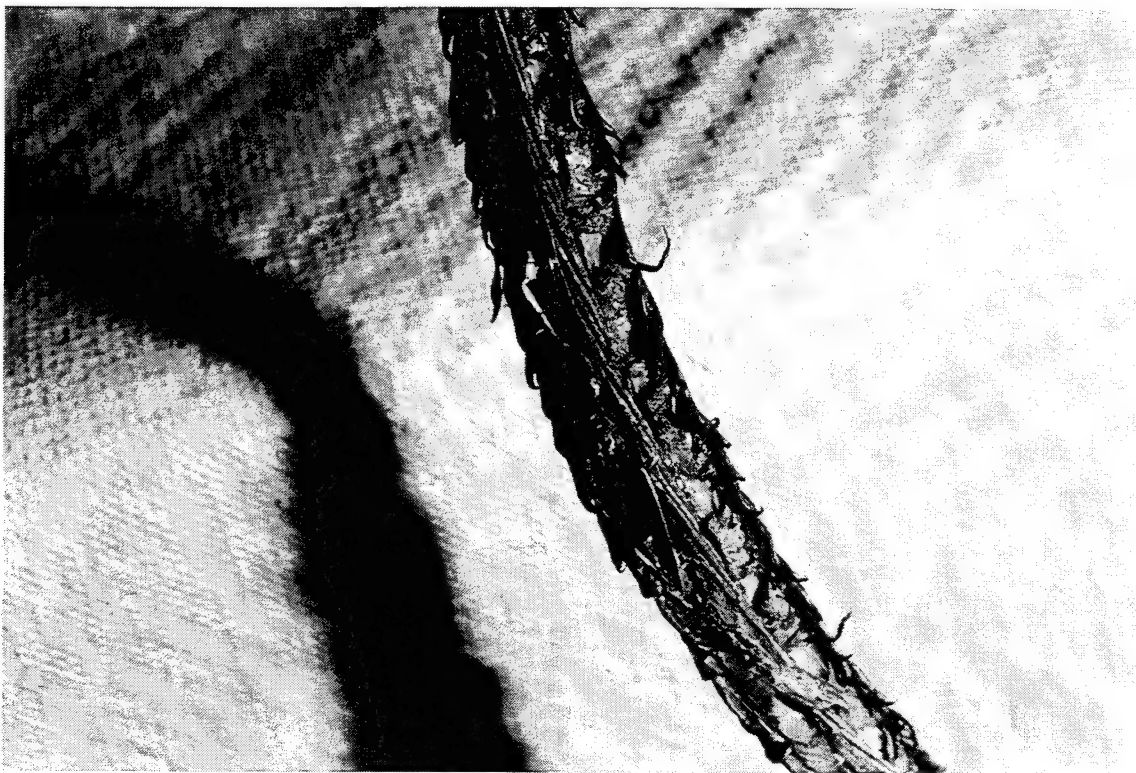
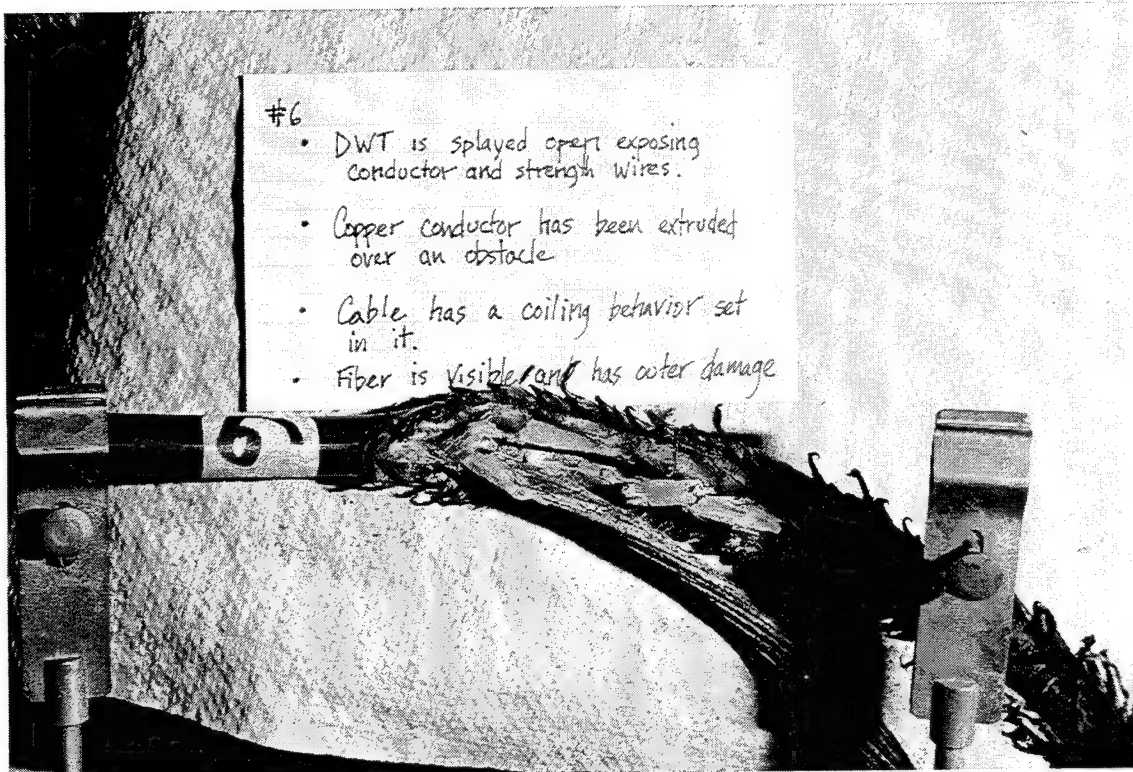
5.8 Fault Number 6 - FDS-D CABLE AUTOPSY WORKSHEET

Condition of Optical Fiber Sheath: The sheath is shredded exposing the buffer. Indentations from where the strength wires deformed the buffer.

Condition of Fiber: There appear to be kinks and bends in the core. Obvious catastrophic failure.

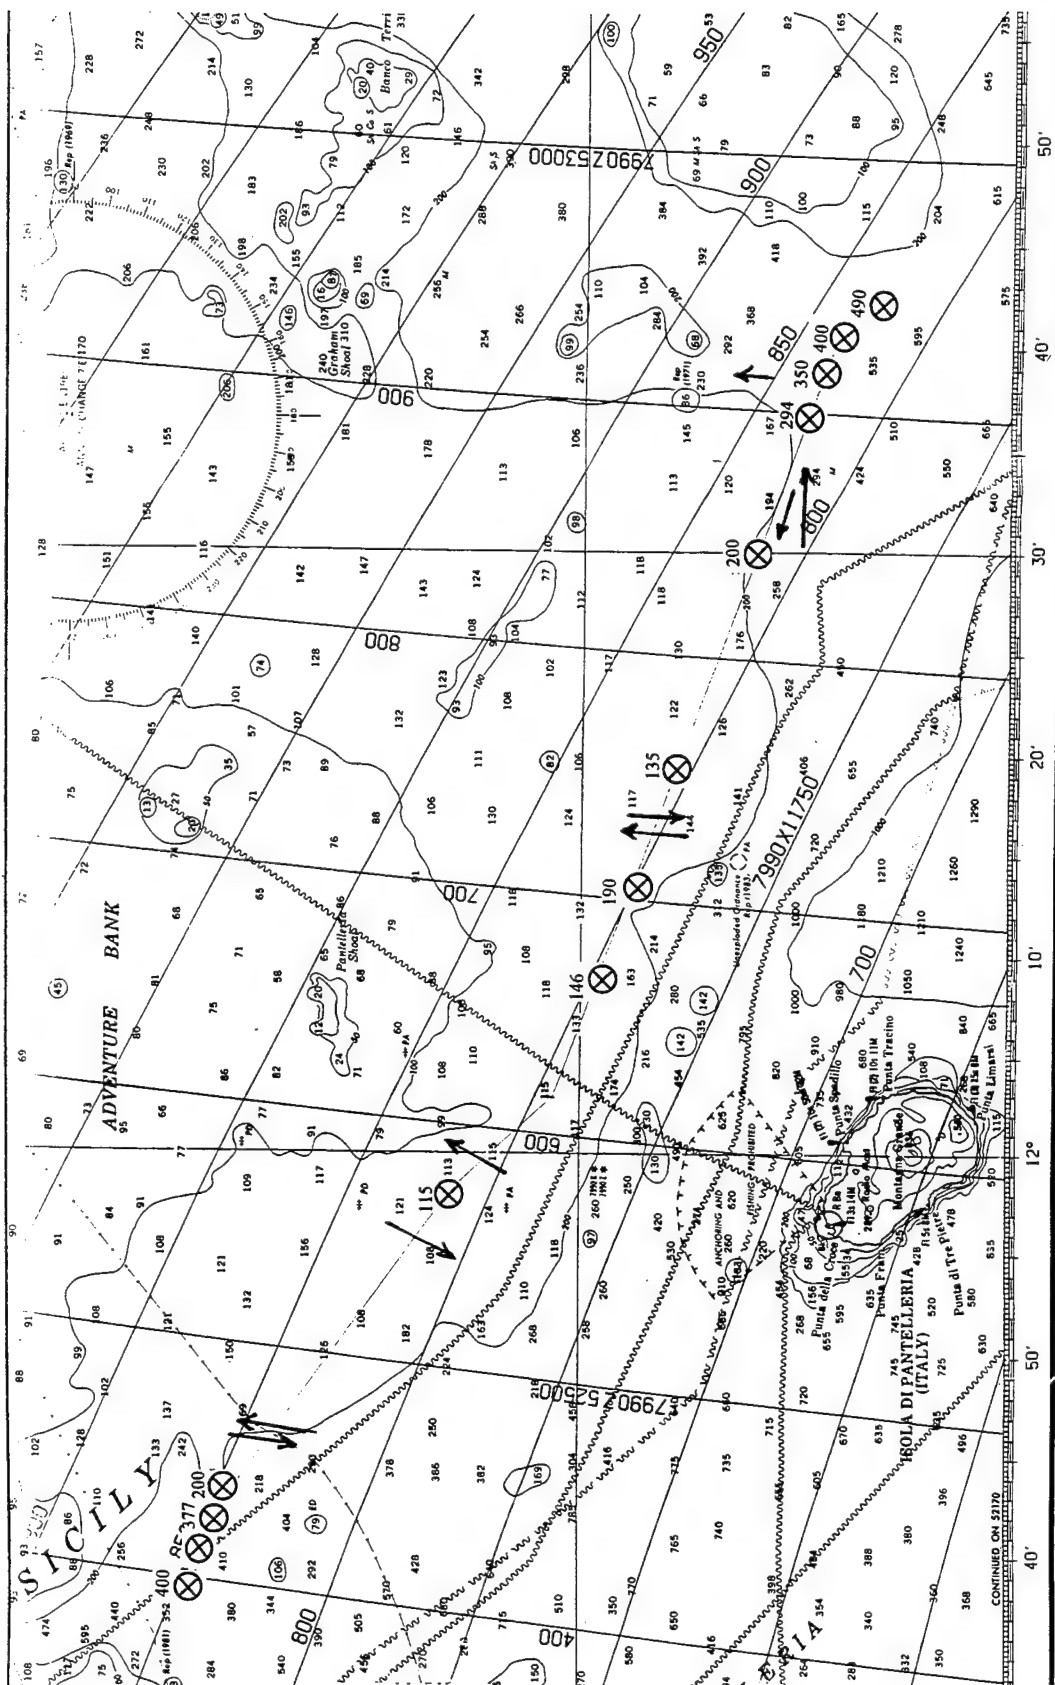
FIGURE B-10. TRAWLING FAULT LOCATIONS

Most of the cable failures (13 out of 15) occurred on the southern edge of a large, 3,000-square mile, shallow water bank. The cable track was along the edge of the bank over a length of 60 NM. The depth in this area ranges from 300 to 1650 feet, the seafloor composition is mostly mud, and the slope ranges between 0% and 10%. The cable faults were spread out over the entire 60-NM length. Approximately 40 NM of the cable track was on a flat area of the bank in a depth between 300 feet and 600 feet. The remaining 20 NM was on the slope of the bank where the depth ranged between 600 and 1800 feet. Of

the 13 cable failure incidents, nine occurred on the slopes on either side of the bank in the depths between 600 and 1800 feet. The failure incident density versus depth was one incident per 2.22 NM between 600 and 1,800 feet deep, and one incident per 9.5 NM between 300 and 600 feet deep. Figure B-9 provides a graph of UWS trunk length versus depth.

Trawlers ranged in length from 50 to 100 feet. The trawlers were identified visually by the bridge watch or project personnel using binoculars. Trawlers could be identified out to a range of about 5 NM. Beyond that range it was difficult to positively identify a vessel of that size. Although a variety of headings were noted, the predominant course of observed trawlers was perpendicular to the cable track with headings between 0 to 50 degrees, and 180 to 230 degrees. The speed of the trawlers ranged between 2.5 and 4 knots. Figure B-10 provides a chart showing fault locations and trawler headings.

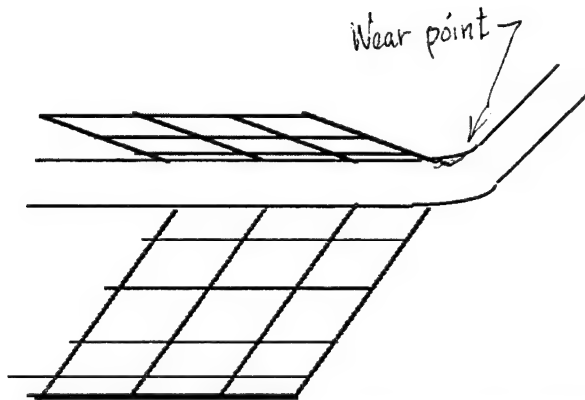
- Copper conductor is ruptured exposing strength wires.
 - Back side of fault area has been worked. Appears to have exceeded elastic limit when bent and buckled upon straightening.

- Cold flow and tearing to outer jacket.
 - Cable bent at a 30° angle where it contacted filter screen.

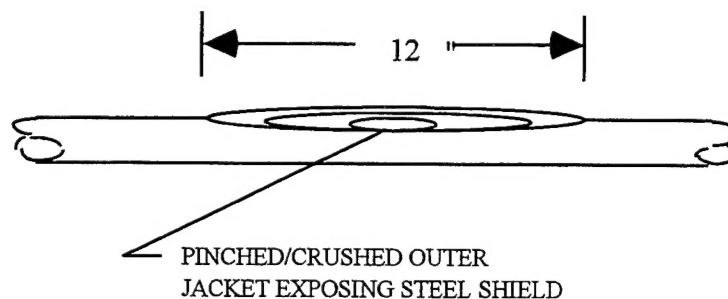
- Fault 4 - Cable was cut with bolt cutters 4 NM shoreward of TR1011. Depth 105 fathoms. I assume a trawler did this after getting its gear entangled with the cable. The cable was recovered further up the track and the trawl damage was never recovered.

- Fault 5 - 2 meters shoreward of TR1011. Depth 80 fathoms. Fault was located near TR1011. Cable had been hit leaving a section 12" long peeled back exposing the shield. There was no obvious sign of damage past the shield. However, testing of TR1011 failed bit error rate tests. The test engineer believes the fault has a high resistance current leak to ground. There is no way of knowing if this is an optical fault because it is too close to the repeater.
